REPORT OF APOLLO 13 REVIEW BOARD

NATIONAL AERONAUTICS AND SPACE ADMINISTRATION

June 15, 1970

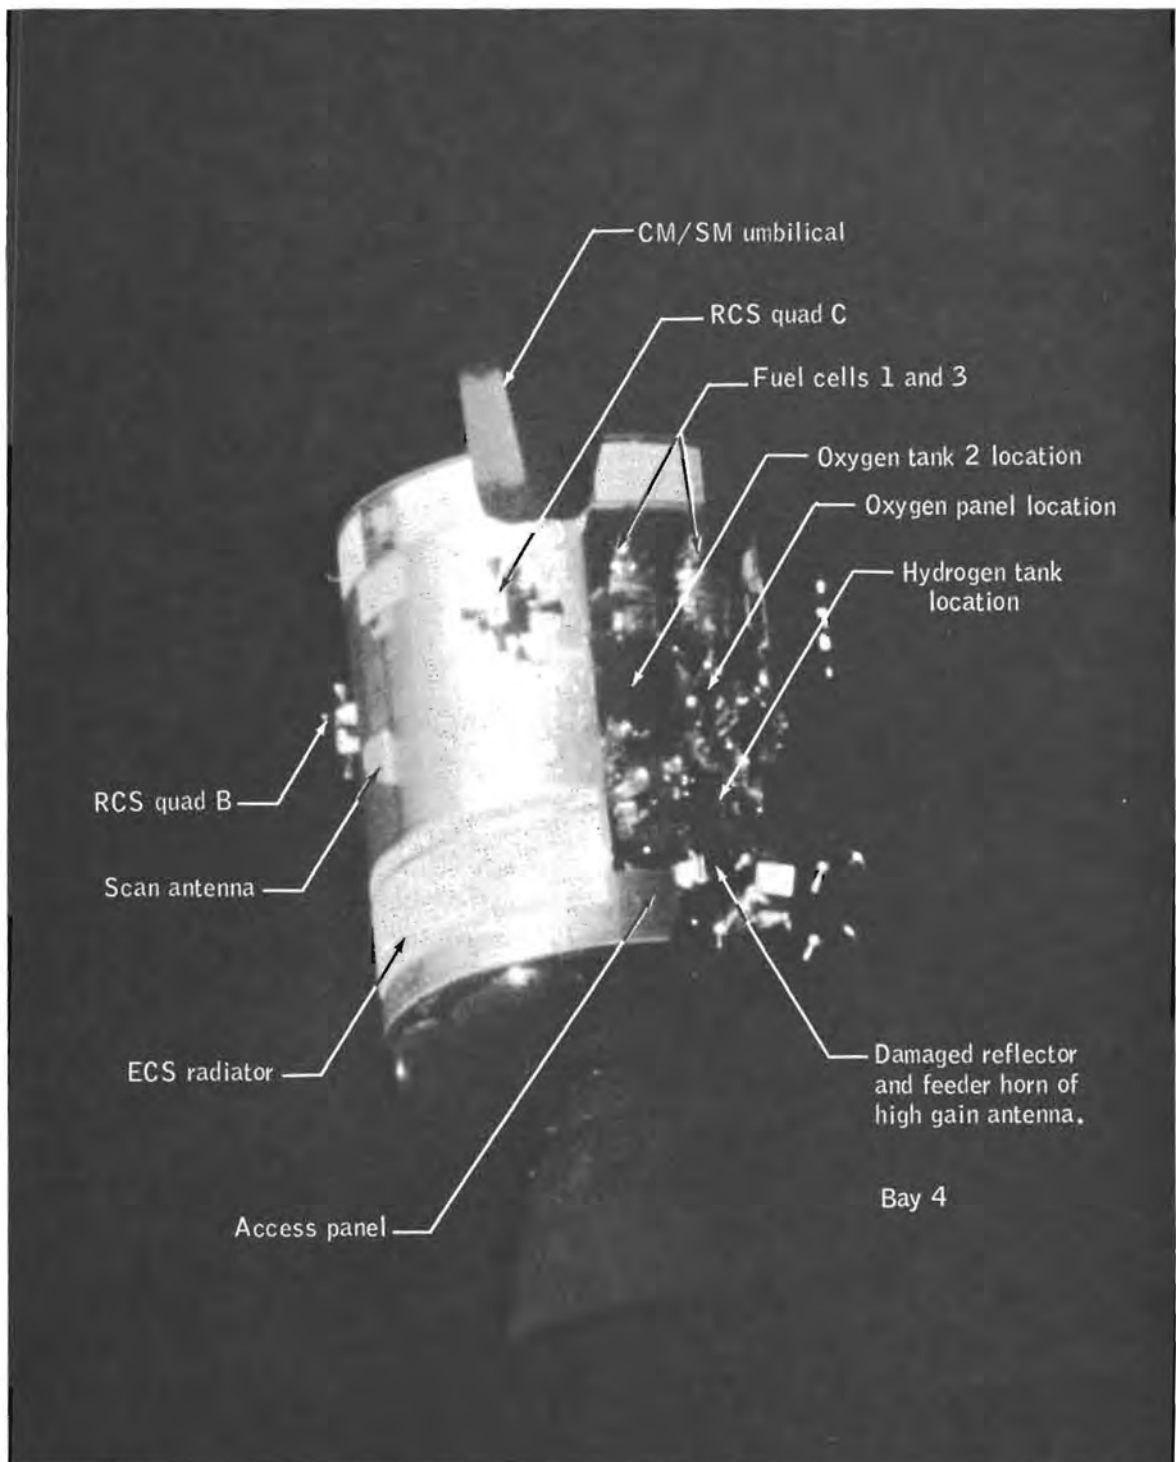
Inflight photograph of service module showing damage to bay 4.

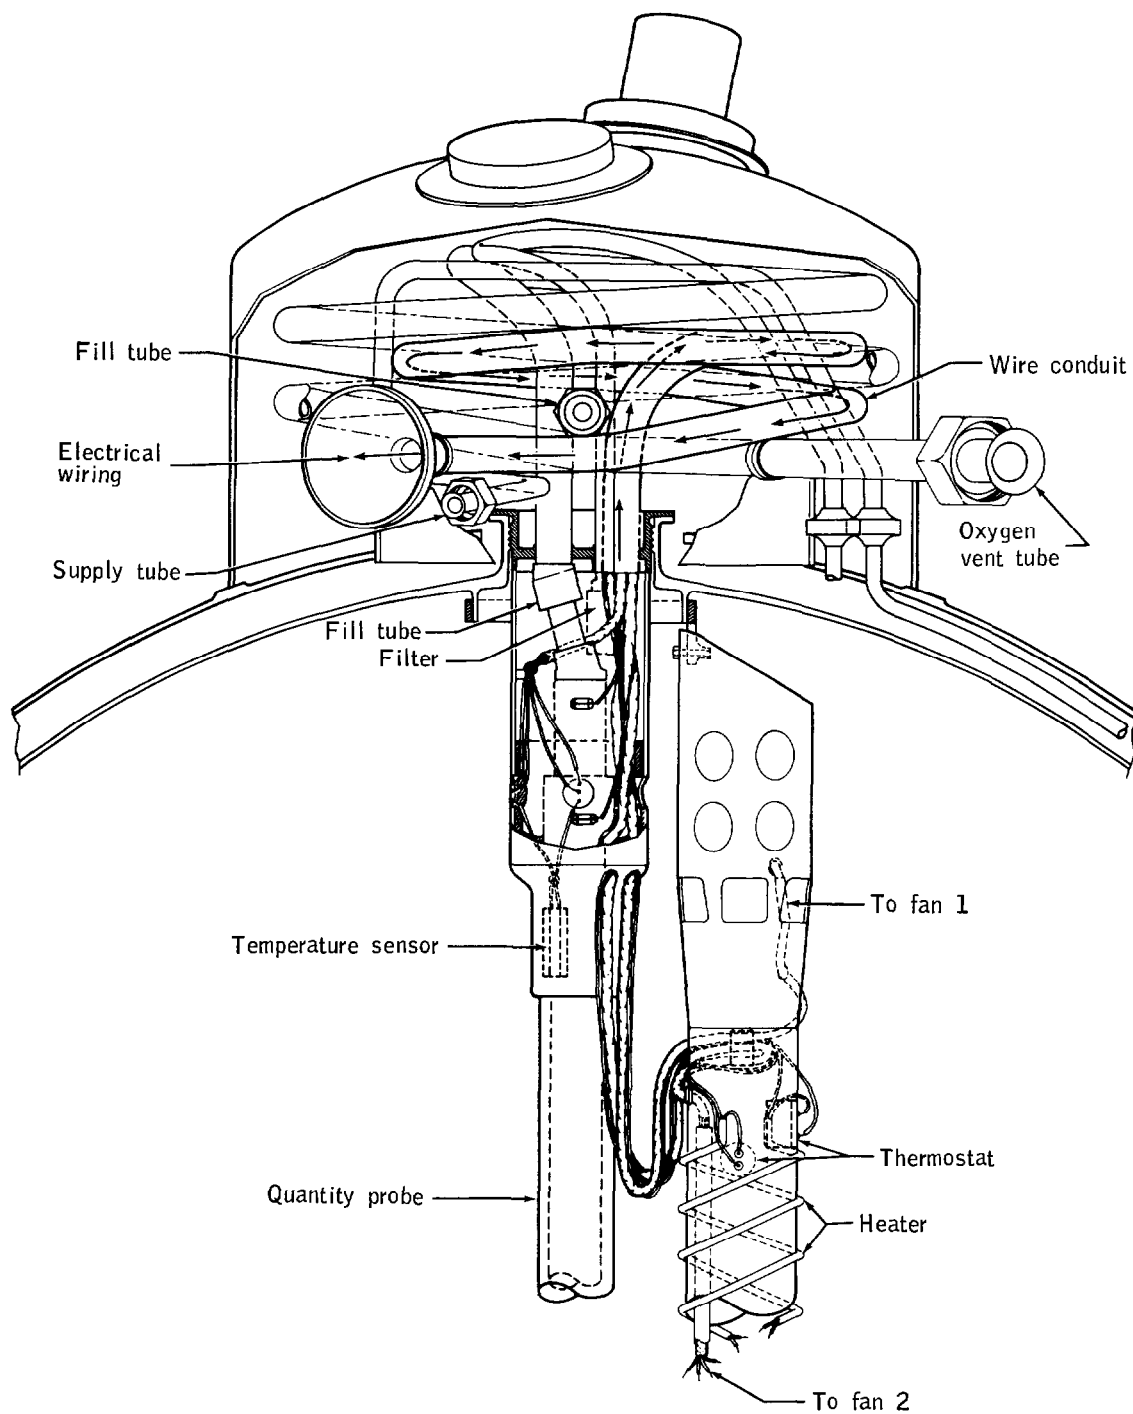
Figure 4-2.- Oxygen tank wiring and lines.

As shown in figure 4-2, the fill line from the exterior of the SM enters the oxygen tank and connects to the inner cylinder of the capacitance gage through a coupling of two Teflon adapters or sleeves and a short length of Inconel tubing. The dimensions and tolerances selected are such that if "worst case" variations in an actual system were to occur, the coupling might not reach from the fill line to the gage cylinder (fig. 4-3). Thus, the variations might be such that a very loose fit would result.

The supply line from the tank leads from the head of the quantity probe to the dome and thence, after passing around the tank between the inner and outer shells, exits through the dome to supply oxygen to the fuel cells in the service module (SM) and the environmental control system (ECS) in the command module (CM). The supply line also connects

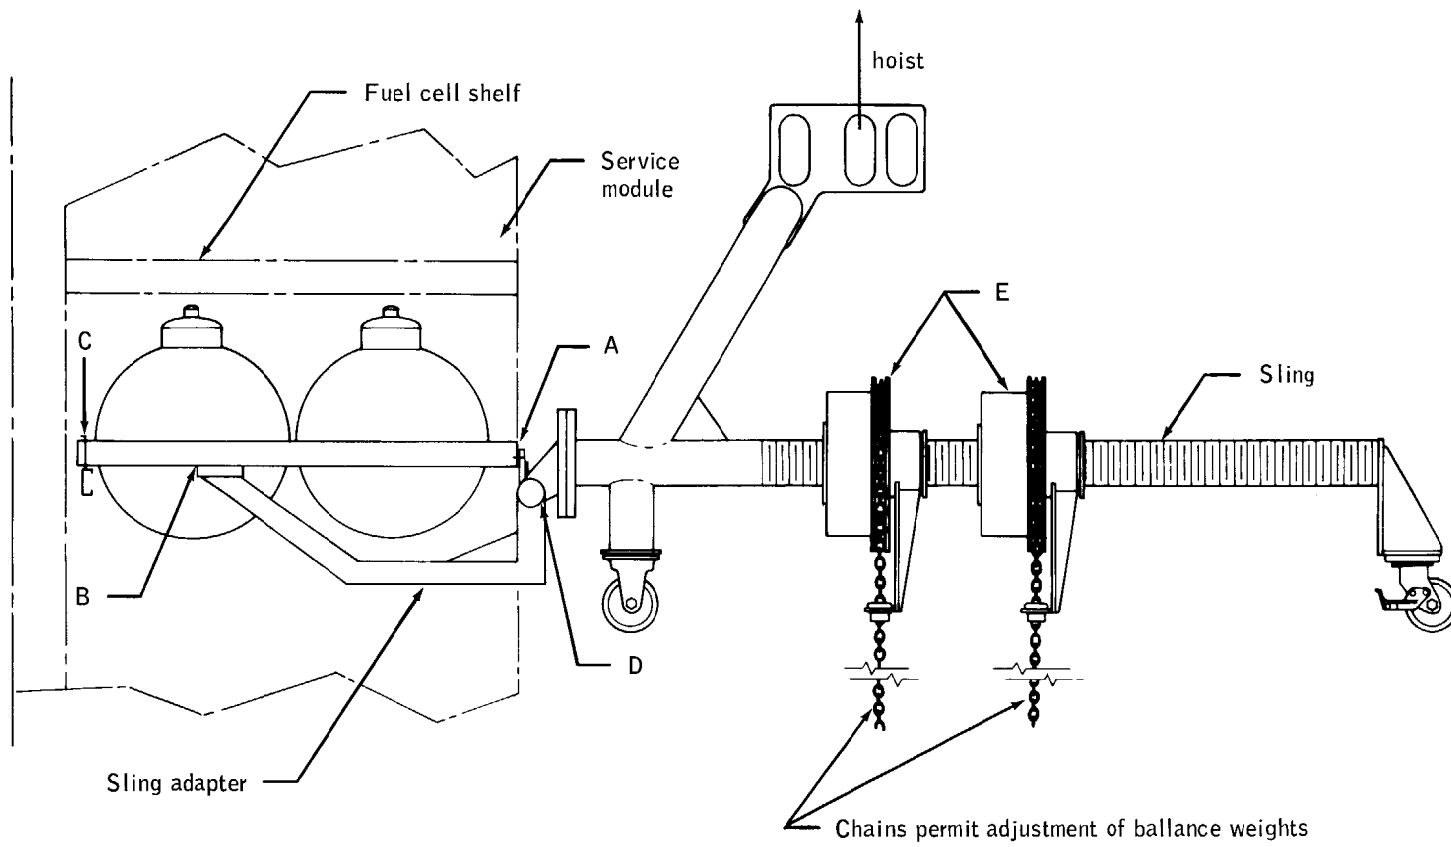
Figure 4-9.- Hoist and sling arrangement - oxygen shelf.

The oxygen shelf was removed in the manner shown in figure 4-9. After various lines and wires were disconnected and bolts which hold the shelf in the SM were removed, a fixture suspended from a crane was placed under the shelf and used to lift the shelf and extract it from bay 4. One shelf bolt was mistakenly left in place during the initial attempt to remove the shelf; and as a consequence, after the front of the shelf was raised about 2 inches, the fixture broke, allowing the shelf to drop back into place. Photographs of the underside of the fuel cell shelf in SM 106 indicate that the closeout cap on the dome of oxygen tank no. 2 may have struck the underside of that shelf during this incident. At the time, however, it was believed that the oxygen shelf had simply dropped back into place and an analysis was performed to calculate the forces resulting from a drop of 2 inches. It now seems likely that the shelf was first accelerated upward and then dropped.

The remaining bolt was then removed, the incident recorded, and the oxygen shelf was removed without further difficulty. Following removal, the oxygen shelf was retested to check shelf integrity, including proof-pressure tests, leak tests, and functional tests of pressure transducers and switches, thermal switches, and vac-ion pumps. No cryogenic testing was conducted. Visual inspection revealed no problem. These tests would have disclosed external leakage or serious internal malfunctions of most types, but would not disclose fill line leakage within oxygen tank no. 2. Further calculations and tests conducted during this investigation, however, have indicated that the forces experienced by the shelf were probably close to those originally

calculated assuming a 2-inch drop only. The probability of tank damage from this incident, therefore, is now considered to be rather low, although it is possible that a loosely fitting fill tube could have been displaced by the event.

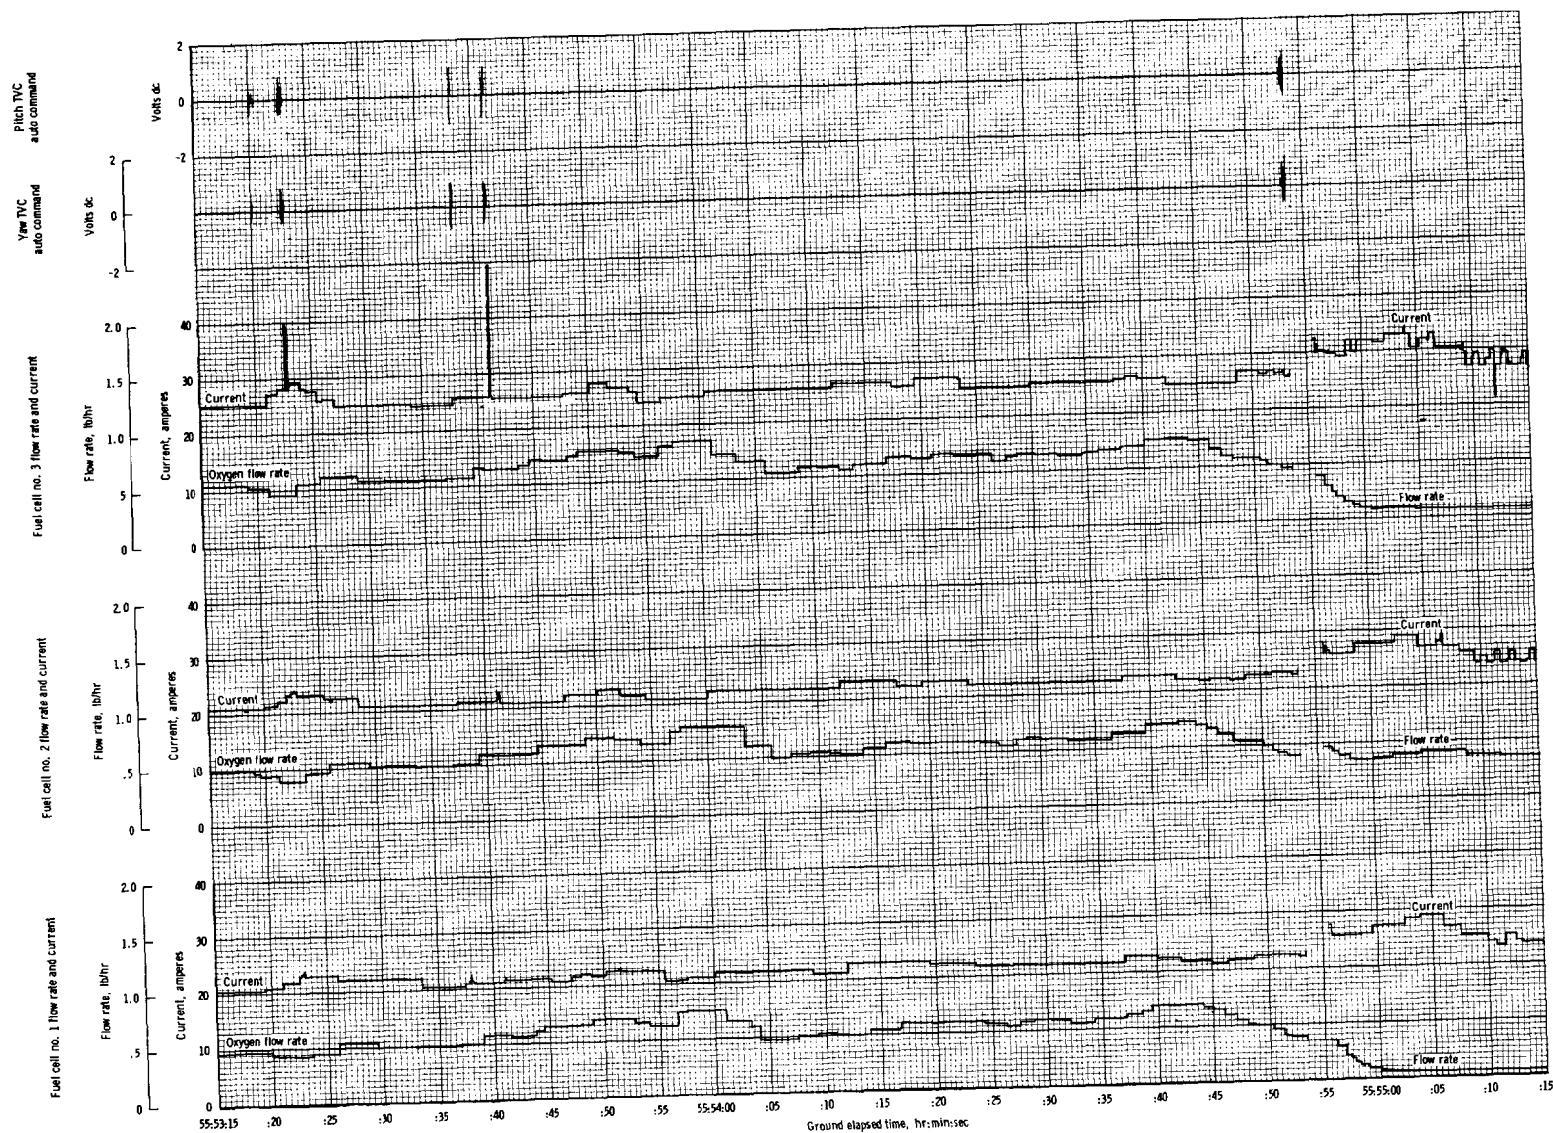
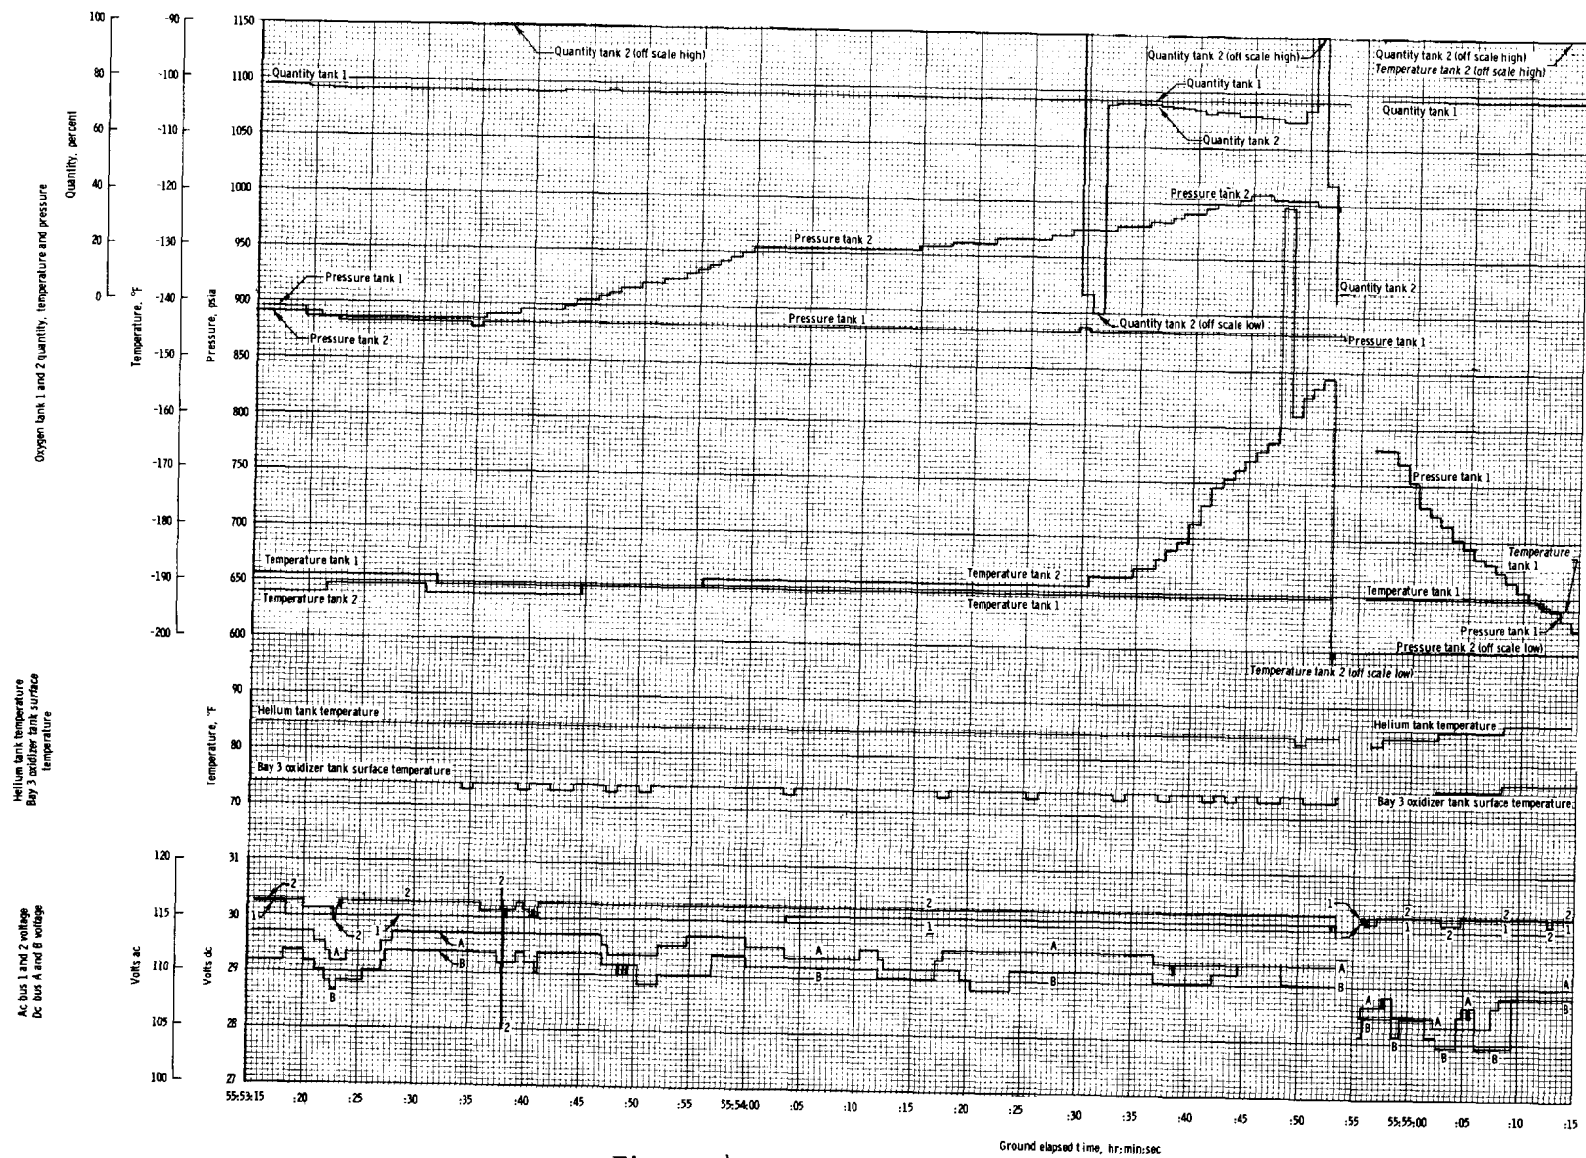
Figure 4-10.- Telemetry record.

The various telemetered parameters of primary interest are shown in figure 4-10 and listed in table 4-11.

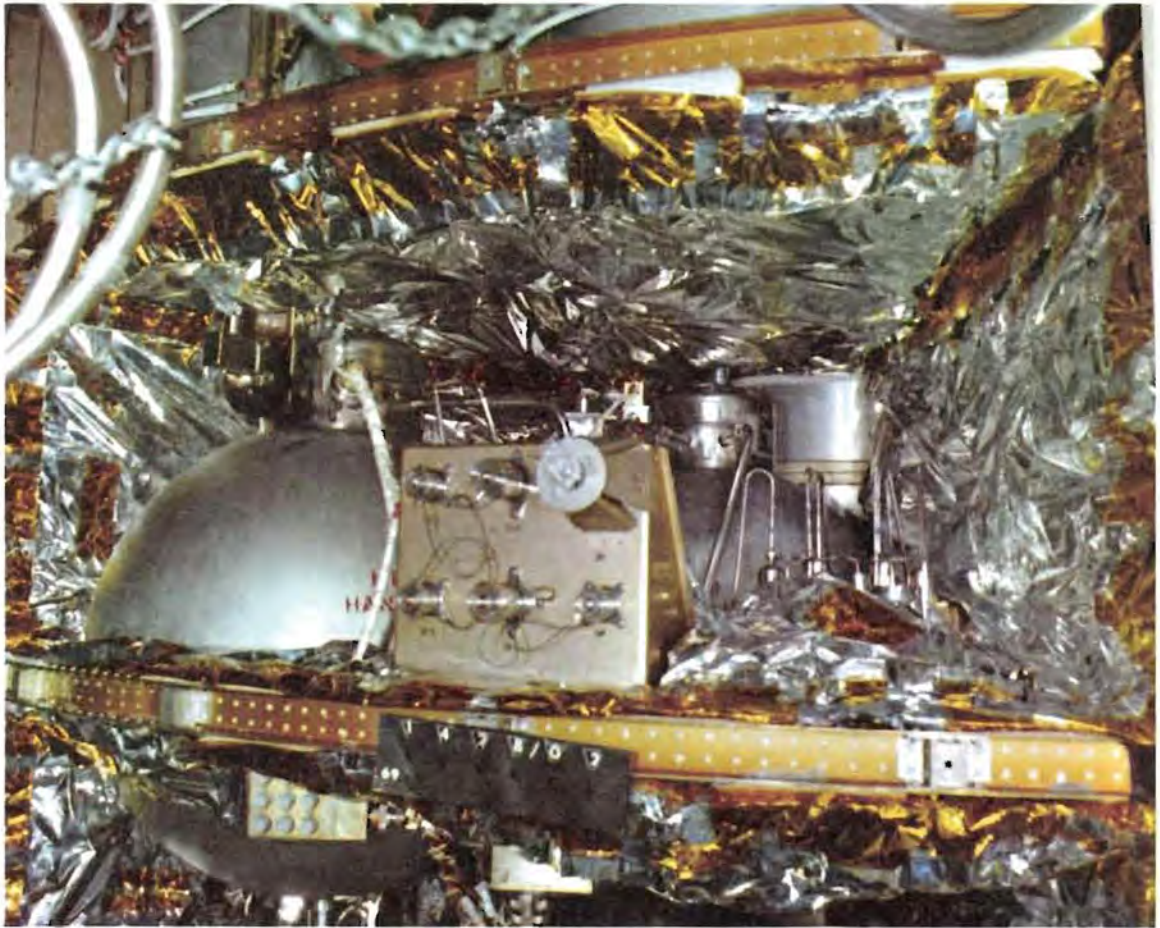
4-11.-
Figure ~~XXX~~ Closeup view of oxygen tank shelf.

Release of the oxygen then began to pressurize the oxygen shelf space of bay 4. If the hole formed in the pressure vessel were large enough and formed rapidly enough, the escaping oxygen alone would be adequate to blow off the bay 4 panel. However, it is also quite possible that the escape of oxygen was accompanied by combustion of Mylar and Kapton (used extensively as thermal insulation in the oxygen shelf compartment, figure 4-11, and in the tank dome) which would augment the

pressure caused by the oxygen itself. The slight temperature increases recorded at various SM locations indicate that combustion external to the tank probably took place. Further testing may shed additional light on the exact mechanism of panel ejection. The ejected panel then struck the high-gain antenna, disrupting communications from the spacecraft for the 1.8 seconds.

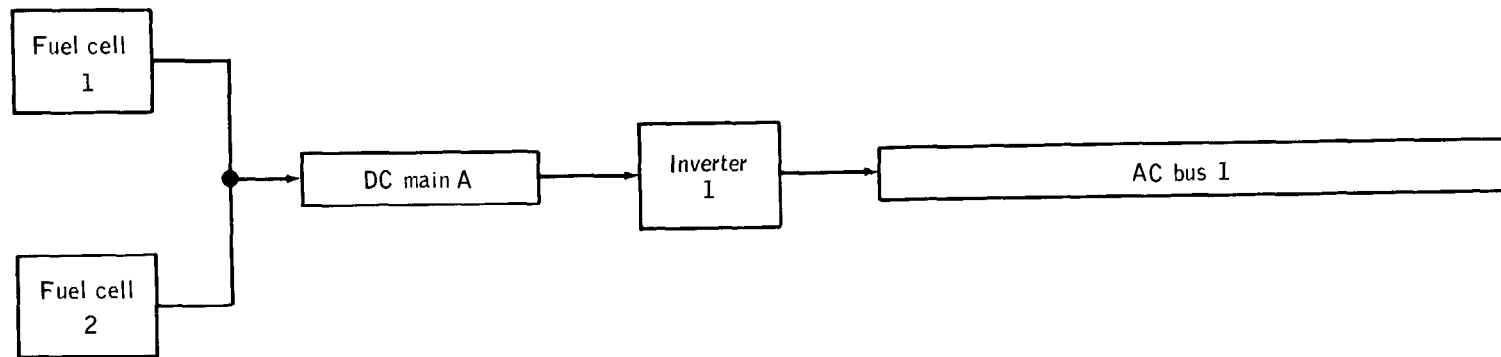
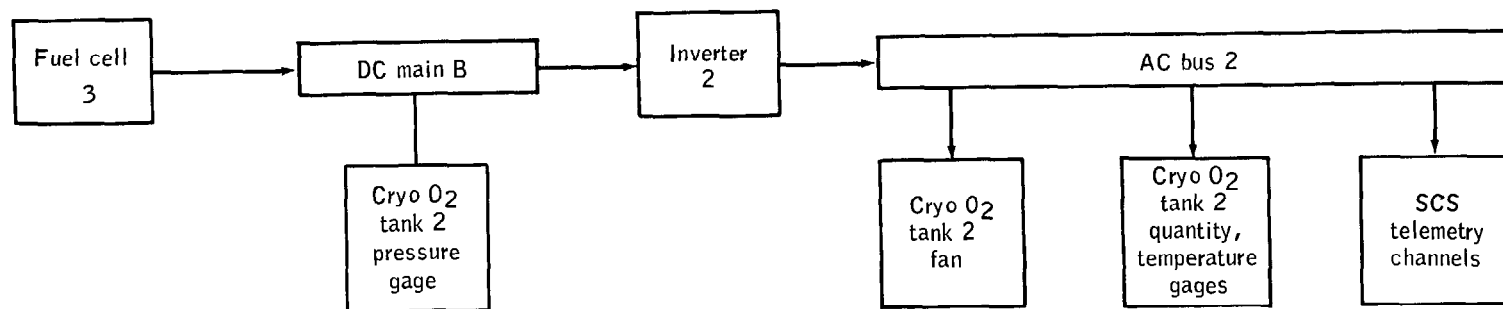
Figure 4-12.- Electrical configuration at 55:54:53 g.e.t.

The crew was not alerted to closure of the oxygen feed valves to fuel cells 1 and 3 because the valve position indicators in the CM were arranged to give warning only if both the oxygen and hydrogen valves closed. The hydrogen valves remained open. The crew had not been alerted to the oxygen tank no. 2 pressure rise or to its subsequent drop because a hydrogen tank low pressure warning had blocked the cryogenic subsystem portion of the caution and warning system several minutes before the accident.
